Alexis VAUCHERET, Cécile NICOLI, Jean-François CARTON, Philippe JACQUET - Influence of Process Parameters on Cerioxide Formation in Low-Carbon Steels - Journal of casting and materials engineering - Vol. 1, n°4, p.90-96 - 2018

# Influence of Process Parameters on Cerioxide Formation in Low-Carbon Steels

## Abstract

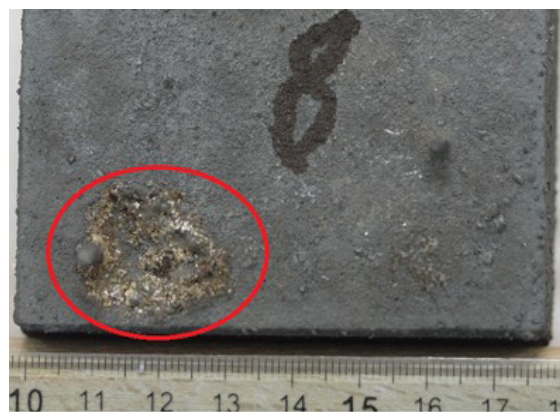
This defect is located on the upper surface of a part [1] and does not affect its core nor its mechanical properties. It is shaped like a circular crater with some bubbles inside or in its outlying area (see Figure 1).

Fig. 1. Top view of cerioxide defect

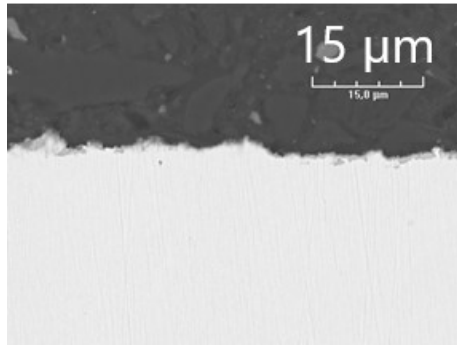
Figures 2 and 3 present cross-section examinations with a scanning electronic microscope outside the ceroxide zone (Fig. 2) and inside (Fig. 3). Outside, the surface seems very “clean,” whereas a several-micrometer-thick layer is observed inside the crater.

**Fig. 2.** Cross-section view outside ceroxide zone (SEM – BSE)

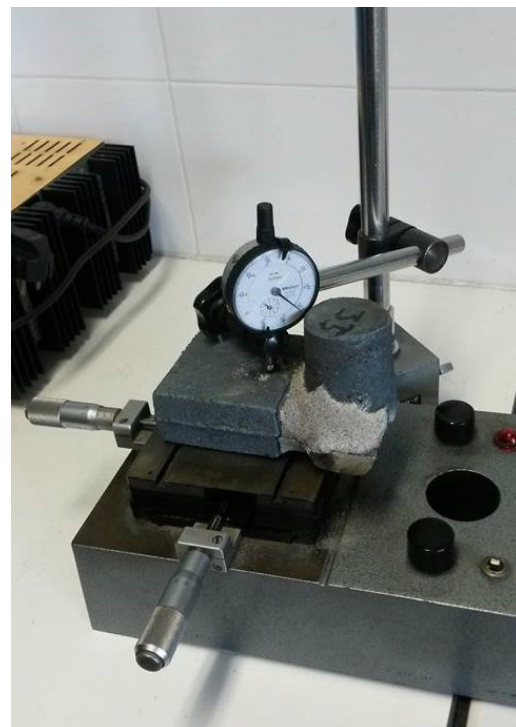
The cerioxide defect has been characterized by its maximum depth measured thanks to a continuous dial indicator and by the ratio between the surface affected by the defect and the total upper surface of Part 1 in Figure 5. Figure 8 presents the system used to measure the depth of the cerioxides.

**Fig. 8.** Measuring tool for cerioxide depth

For this characterization, the entire crater has been measured and only the maximum value of each sample has been conserved. These maximal depths are presented in Tables 2–4.

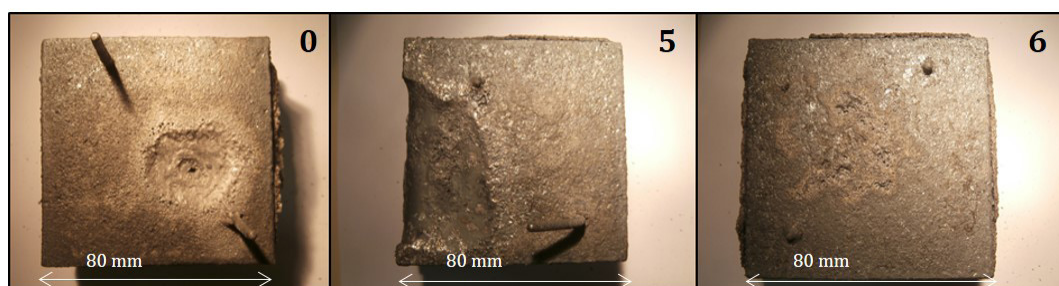
Fig. 11. Influence of different coatings on ceroxide formation

Two combustibles were chosen due to their different air-requirements for combustion: linseed oil and fuel oil. The change of atmosphere in the mold was principally used to improve surface roughness [12] most particularly with a linseed oil or graphite coating. Finally, the results gave for both trials a ceroxide, but the surface and the depth were very different on each sample (see Table 4 and Figure 11). The fuel oil coating decreased the size and depth of the defect; this was contrary to the linseed oil, which increased both when compared to the reference. Nevertheless, the linseed oil coating improved the surface roughness of the sample on the surface not affected by the ceroxide corroborating [12].

The fuel oil coating gave promising results, but its utilization in an industrial context should be difficult due to security rules. Indeed, fuel oil burned during the metal casting, so some flames were visible by the riser on the top of the mold. It is possible to suppose that an important part of the oxygen present in the mold was consumed for fuel oil combustion and not to react with aluminum.
